52-11-1 Emigh Applies to All Trojan A-2 Model Aircraft.

Compliance required by August 1, 1952.

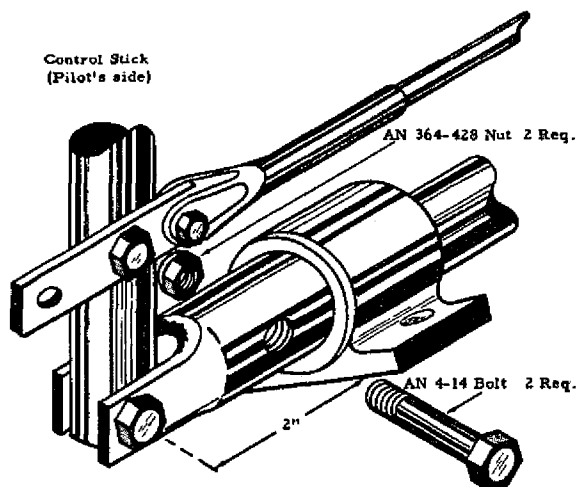
FIGURE 1

As the result of a reported failure of the welded joint in the elevator control tube socket, the following, or equivalent, should be accomplished, to preclude the possibility of recurrence of this type failure:

(a) Install a 1/4-inch AN steel bolt through the elevator control tube socket as shown in Figure 1 and secure with an elastic stop nut. Two installations will be necessary, one on the pilot's side and one on the passenger's.

(b) Due to the limited amount of clearance, it is recommended that the bolts be installed in the direction and location as shown. Ascertain that adequate clearance is provided when the control stick is operated throughout its full range.
